Subject: King Tutt Mesa Site, Reassessment Report EPA ID NO.: NND986667434

Reassessment Report King Tutt Mesa Site Oak Springs, Apache County, Arizona

EPA ID No.: NND986667434 USACE Contract No.: W91238-06-F-0083 Document Control No.: 12767.063.419.1650

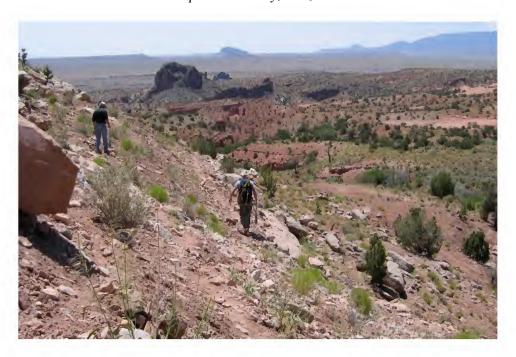
Photo 1: WESTON collecting gamma radiation measurements along a steep slope of the Oak Springs Mine.

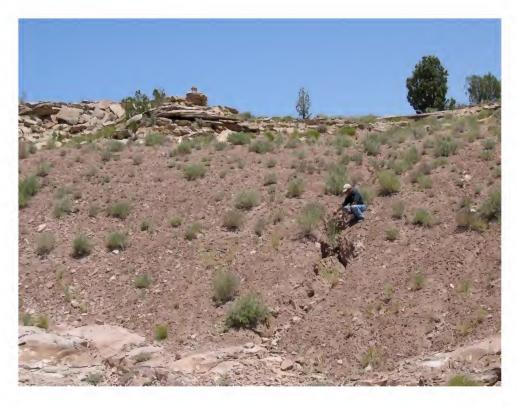
Photo 2: WESTON detected gamma measurements in excess of 100,000 cpm in an eroded section of the cap at the VCA Plot 7 Mines.

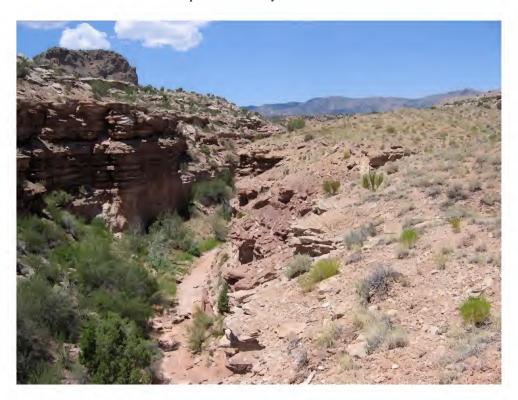
Photo 3: View of the Oak Spring Wash adjacent to the VCA Plot 7 Mines.

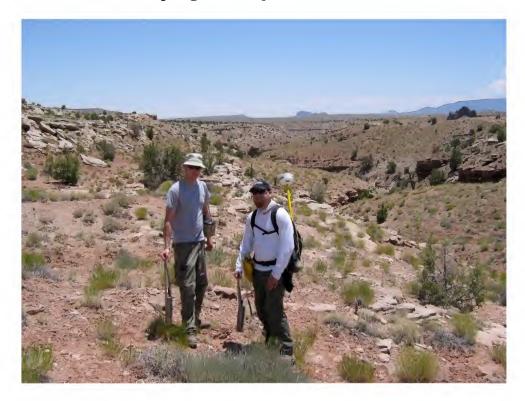
Photo 4: WESTON used a combination sodium-iodide scintillation detector and a GPS unit (right). A stand-alone scintillation detector also was used (left).

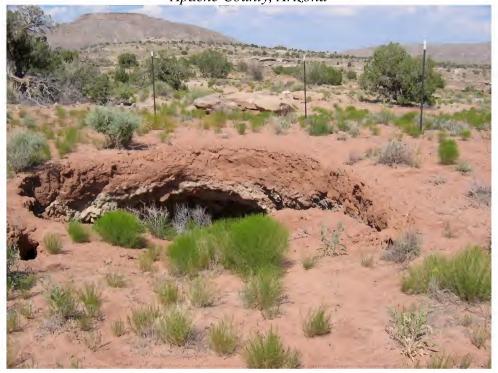
extended from the northeast corner of Nelson Point Mine through the Tent Mine. Additionally, elevated readings were detected at a portion of the cap at NA-0806 that has subsided; however, this area was previously identified by NAMLP for future maintenance, and the subsided area is currently fenced off.

Photo 5: A section of the cap at NA-0806 has subsided. The NAMLRP has identified the area and surrounded it with a fence.

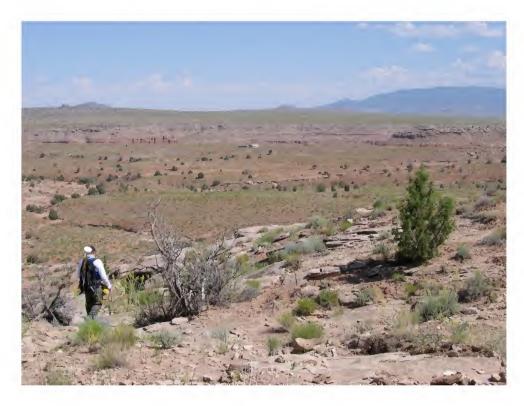
Photo 6: WESTON detected elevated gamma radiation measurements in a natural drainage channel (left) that extends from the northeast corner of Nelson Point Mine.

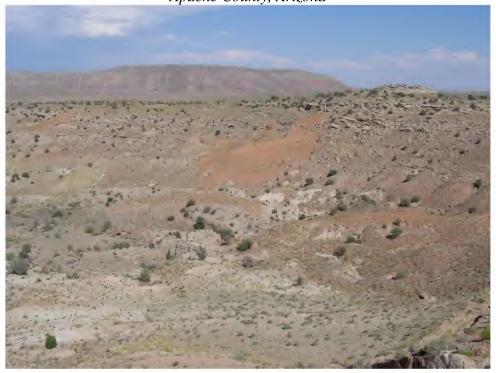
Photo 7: View of the reclamation cap at the Shadyside No. 1 Mine from the Lookout Point Mine. The darker red soil in the center of the photo is the cap.

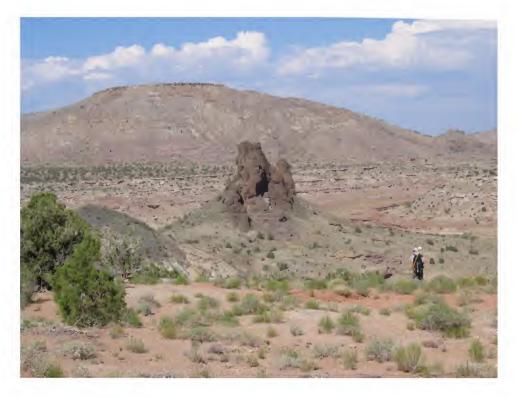
Photo 8: View of WESTON collecting gamma radiation measurements at capped section of the Lookout Point Mine.
